THE PROMISED LAND

Master Bath Renovation

1027 Leland Estates Drive
Leland, Michigan

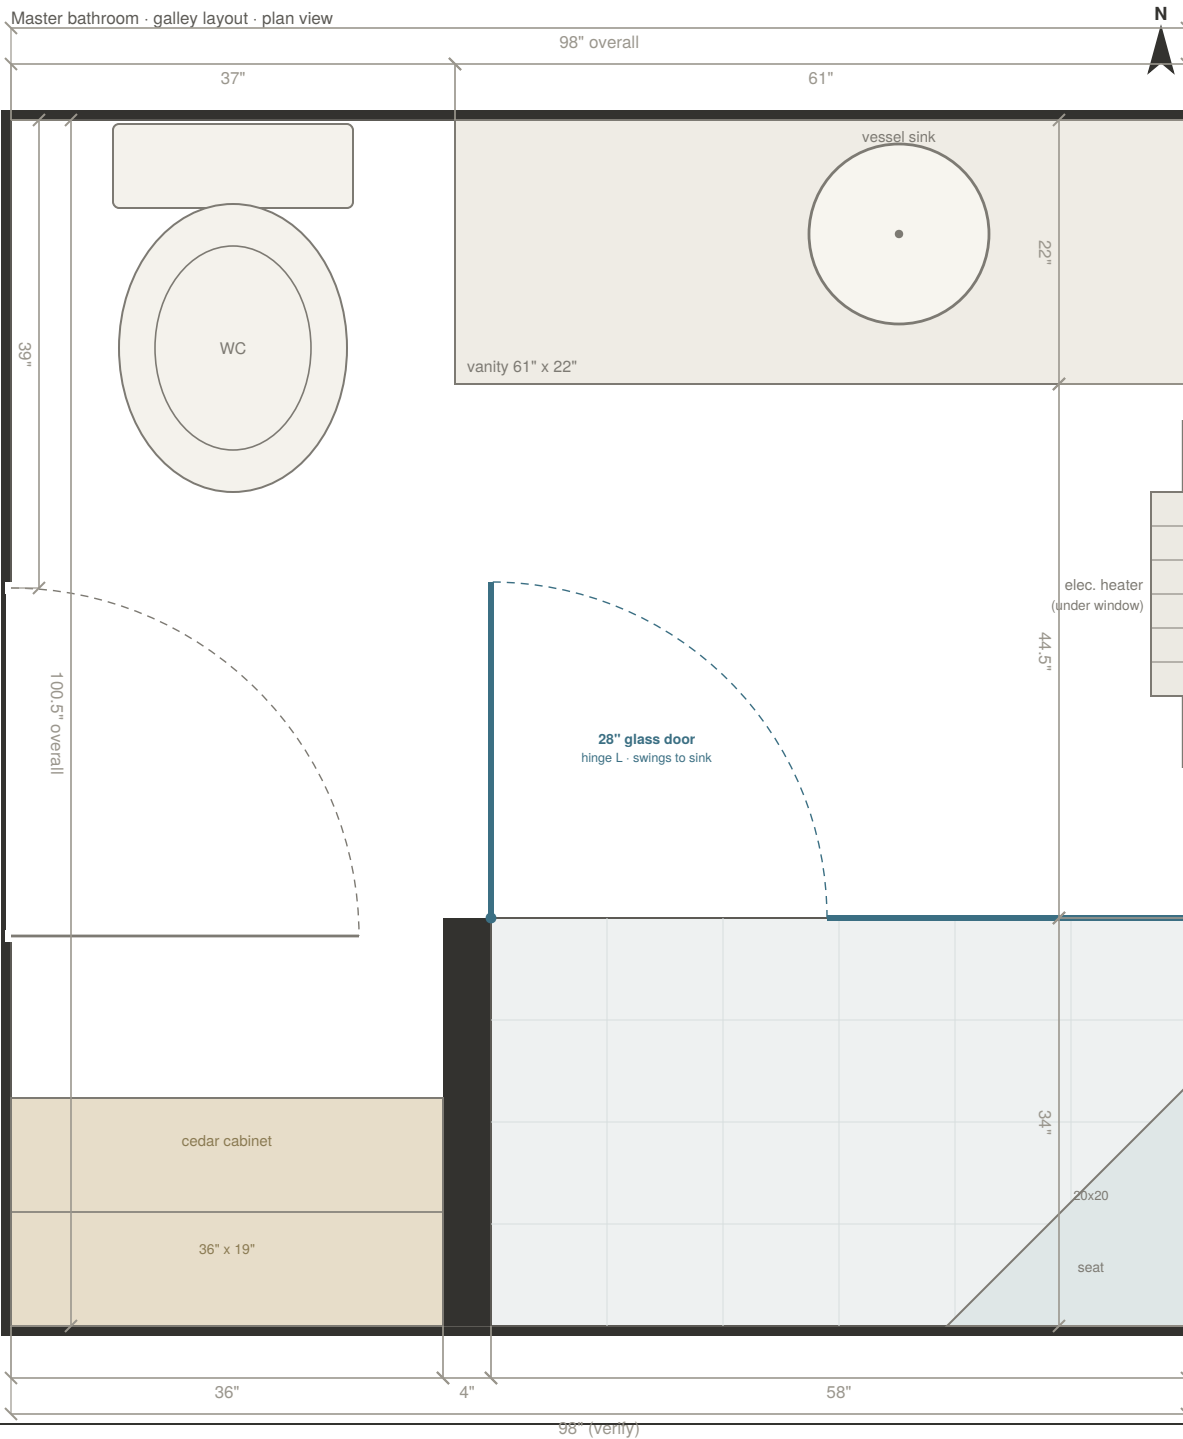
SHEET A-1

Existing Conditions — Floor Plan

Existing master bath, as measured.
Rectangular galley, 98" x 100.5".
Toilet alcove, 61" vanity, cedar cabinet,
and tile shower with corner seat.
Openings and fixtures shown existing.

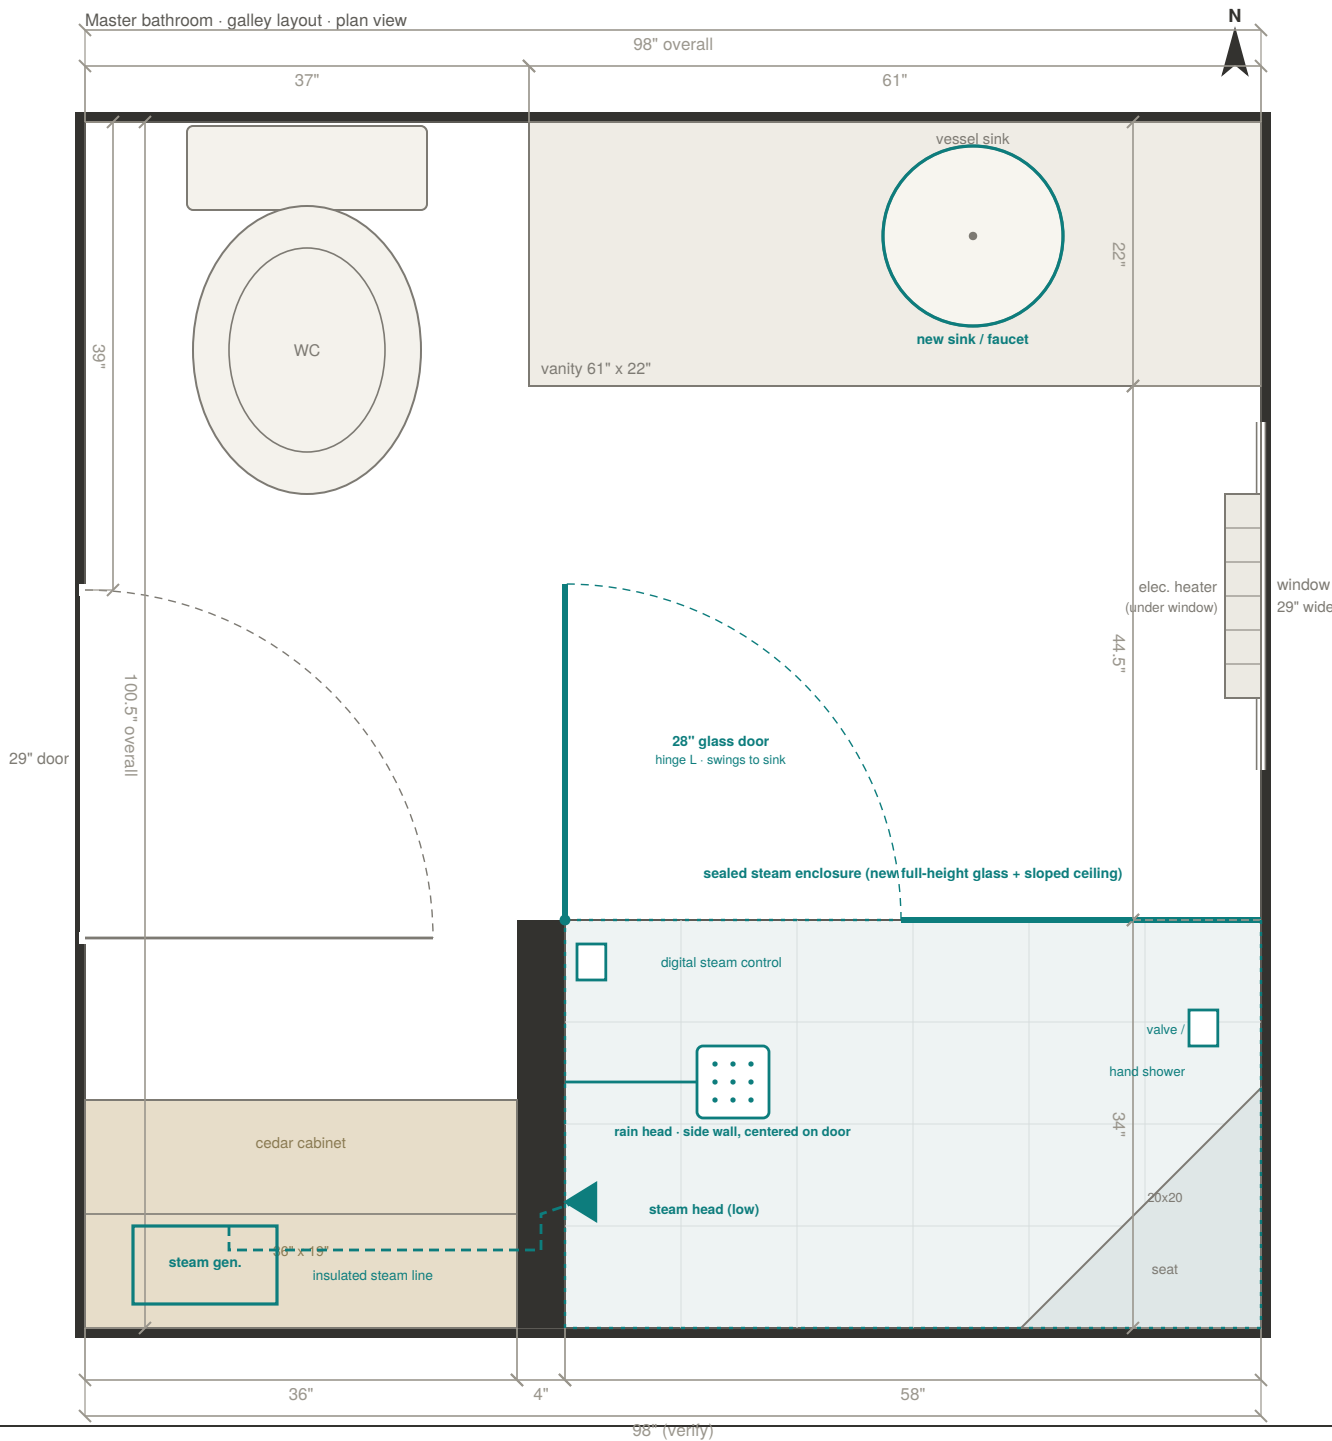
SHEET A-2

Proposed — Steam Shower & Fixture Update

Convert existing shower to a steam shower: sealed full-height glass + new sloped ceiling; steam generator in lower cabinet; new sink/faucet, rain head, hand shower & valve. Walls, window, heater, toilet & cabinet to remain.
